**Forest
Practices
Board**

Maintenance of the Cooke Creek Forest Service Road near Enderby

Complaint Investigation #15083

October 2016

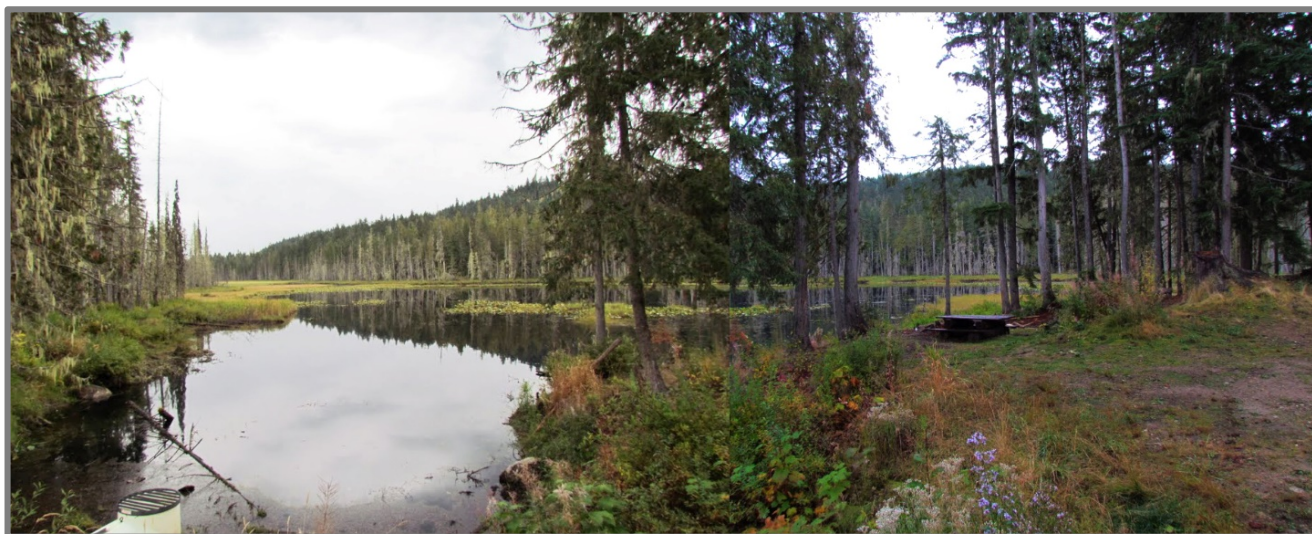
Figure 1. The Dale Lake recreation site on September 25, 2011. The top of a beaver proof culvert is visible in the lower left.

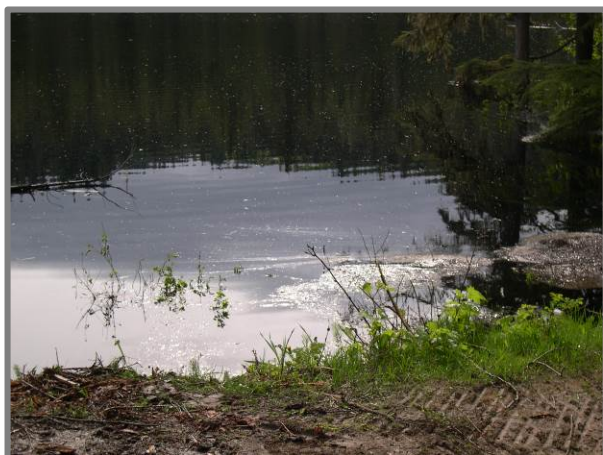
In May 2004, BC Timber Sales (BCTS) discovered that the Dale Lake culvert was plugged and the inlet was under 10 feet of water. Water also overtopped the FSR at a low section at the 8.5 kilometre point (see Map 1). BCTS cleaned out the culvert with a backhoe, however it continued to plug up. BCTS monitored and cleaned out the culvert over a period of four days until the lake level fell and remained at the elevation of the culvert (see Figures 2-5).

Figure 2. May 27, 2004 – Culvert inlet is 10 feet below the surface.

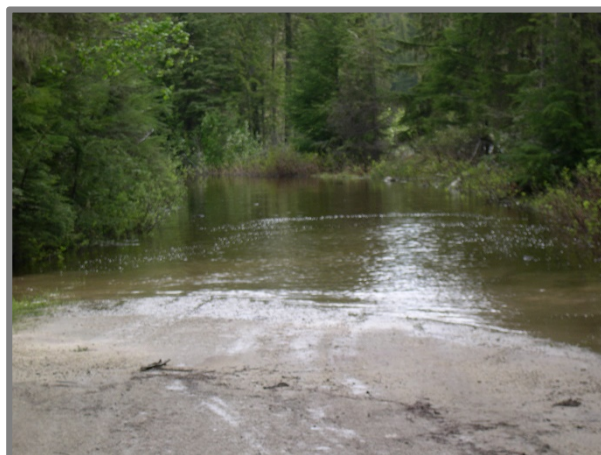
Figure 3. May 27, 2004 – Water from Dale Lake overtopping the Cooke Creek FSR at the 8.5-kilometre point.

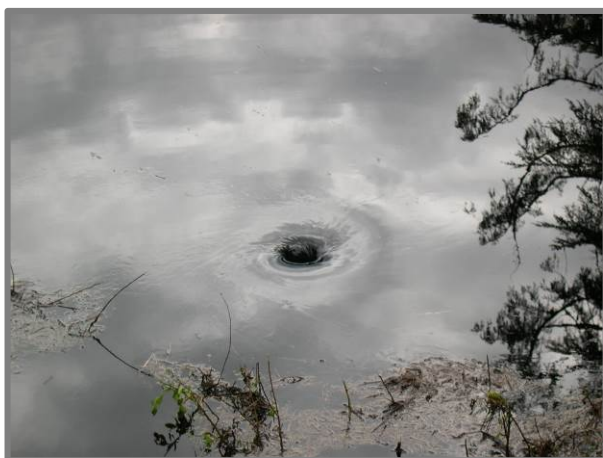
Figure 4. May 27, 2004 – The culvert inlet has been unplugged and the lake is draining.

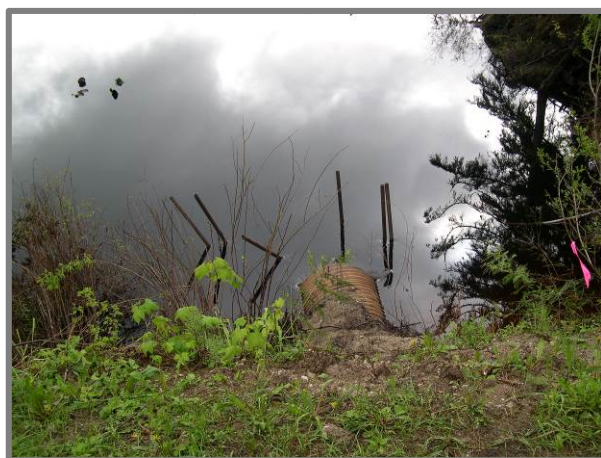
Figure 5. May 31, 2004 – The culvert is once again functional. The metal pipes of the debris catch are intended to prevent debris from entering the culvert.

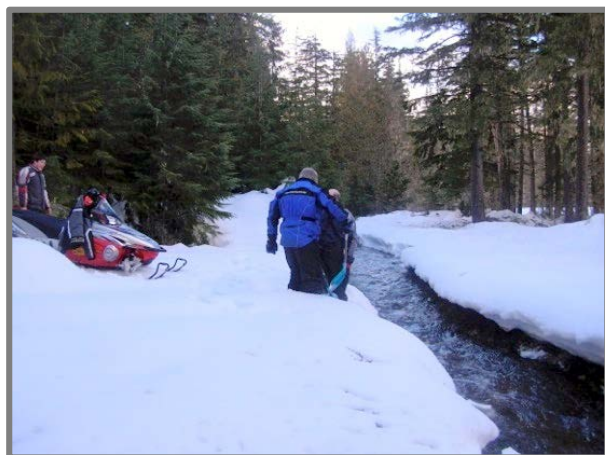
Figure 6. March 25, 2007 – Water from Dale Lake running down the Cooke Creek FSR at the 8.5-kilometre point

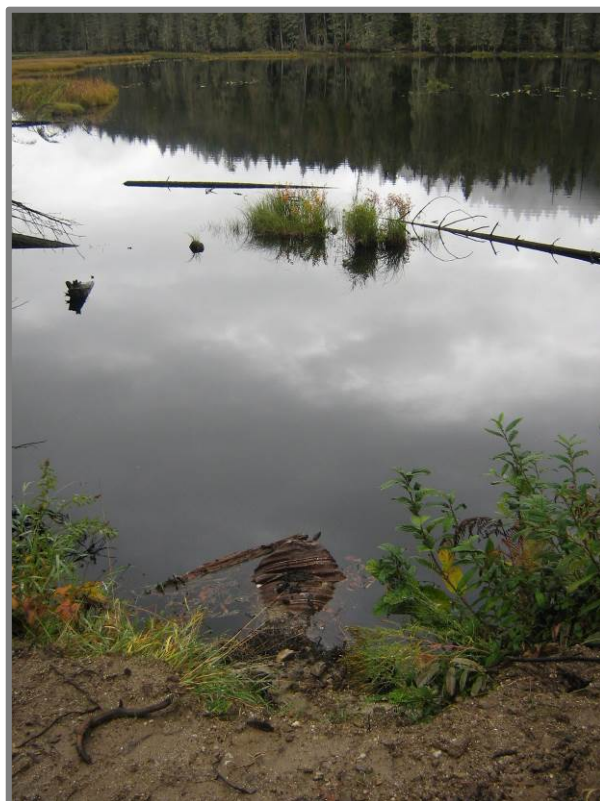
Figure 7. October 4, 2007 – The culvert inlet is damaged and almost completely submerged. A second culvert with a beaver proof add-on was installed five days later.

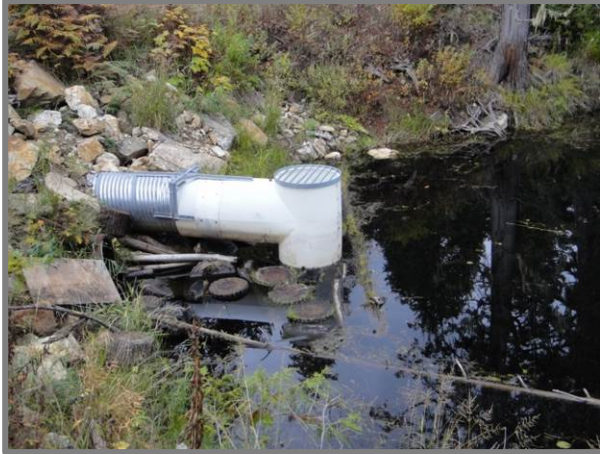
An October 11, 2010, picture shows that the original lower culvert is controlling the lake level. The beaver proof culvert is above the lake level; however, a watermark shows that water was passing through it previously (see Figures 8 and 9).

Figure 8. October 11, 2010 – The beaver proof add-on attached to the culvert inlet. The original, lower culvert is just visible behind the rectangular piece of material, (possibly plywood). Note the floating blocks of wood.

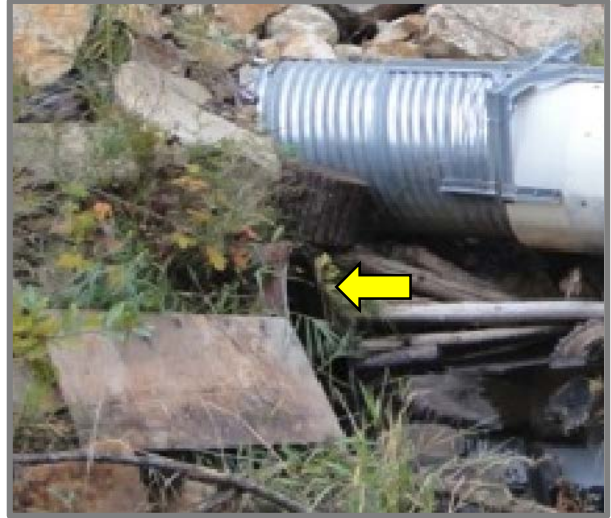
Figure 9. Close up of the previous photo. The arrow points to the lower culvert inlet.

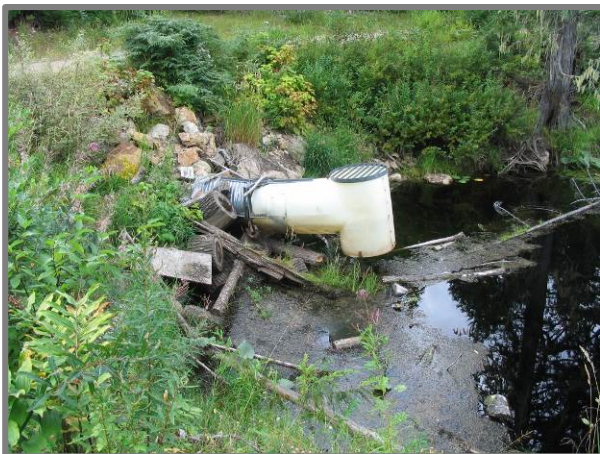
Figure 10. August 21, 2012 – The beaver proof add-on is not seated properly. The original, lower culvert is obscured by debris. Some of the blocks of wood that can be seen floating in Figure 8, taken two years earlier, now appear to be restricting the lower culvert. Cooke Creek FSR is visible in the top left.

I believe it is repairable but would need a backhoe with an extended reach or a small excavator to remove all the old blocks of wood that are jammed all around the old lower outlet pipe. I think a bit of pressure from a hoe bucket would lower the plastic thingy enough to re-establish some hardware and cinch it all up tight again.

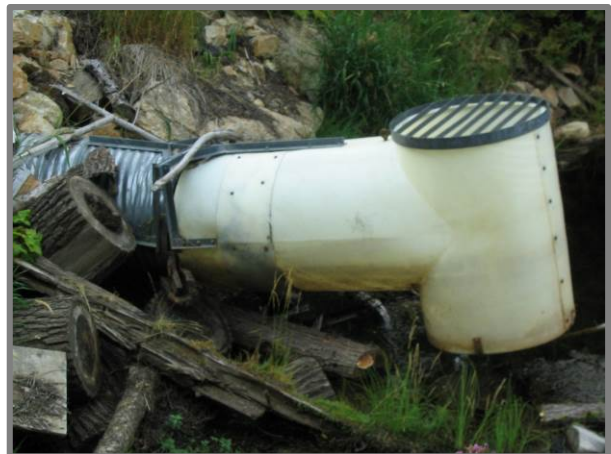
Figure 11. A water line is visible on the beaver proof add-on indicating it was controlling the lake level.

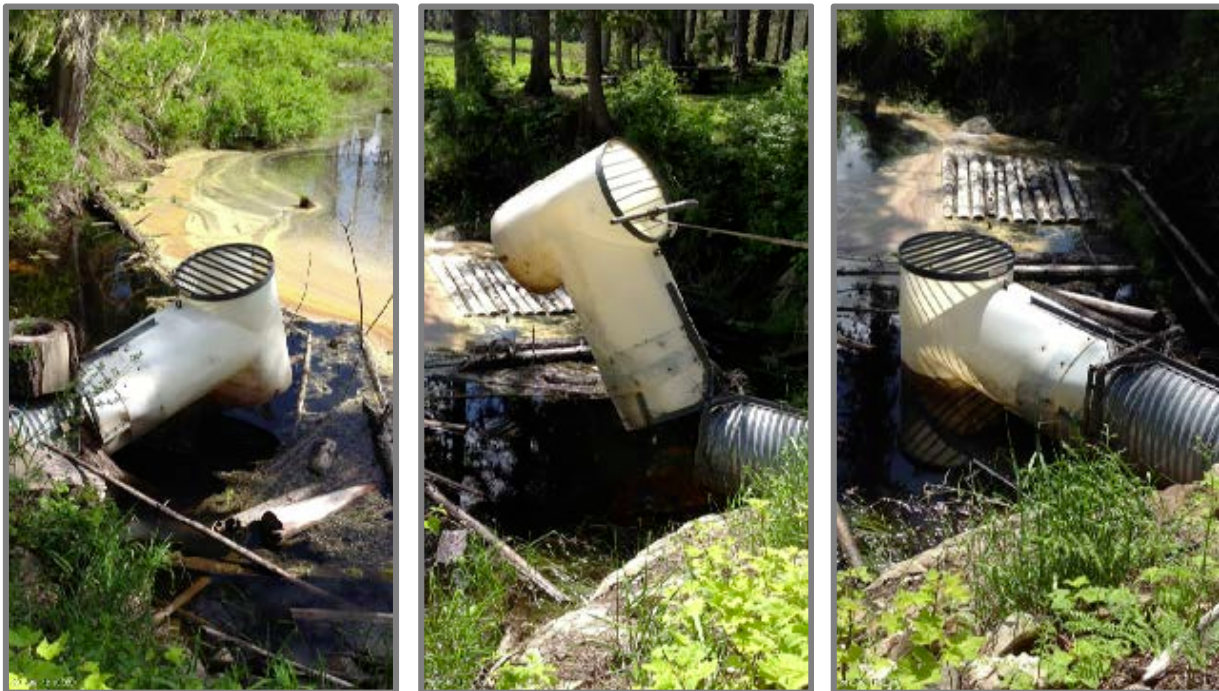
District staff inspected the beaver proof culvert three days later on June 12, 2013. Inspection photos show that the beaver proof add-on was held aloft by debris (see Figure 12). Staff cleaned it out and ensured that it was seated properly (Figures 13 and 14). The inspection report noted "Dual 800-mm CMPS are located at this crossing - drainage appears to be an ongoing issue. Recommend on-going monitoring inspections."

Figures 12, 13, 14. June 13, 2013 – Ministry inspection photos. (Left) The beaver proof add-on held aloft by debris. (Middle) Staff pulled up the add-on to clean it out. (Right) The add-on was put back in place.

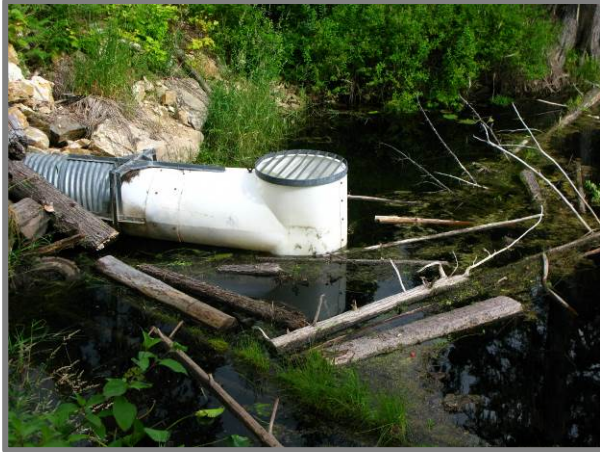
Figure 15. July 12, 2013 – The beaver proof add-on is controlling the lake level.

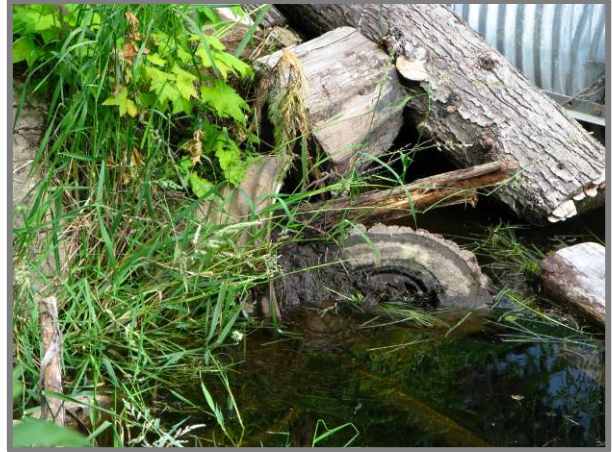
Figure 16. July 12, 2013 – Close-up of the lower culvert inlet described as "mostly blocked" by the complainant. The upper beaver proof culvert is visible in the top right.

A month after the district's June 2013 inspection, the complainant sent photos and a message to district staff⁷ that the lower culvert was "mostly blocked" and "very little water is actually flowing through." A photo taken in September 2013 by a Tolko employee shows only a trickle of water coming out of the lower culvert, indicating that it was almost completely blocked.

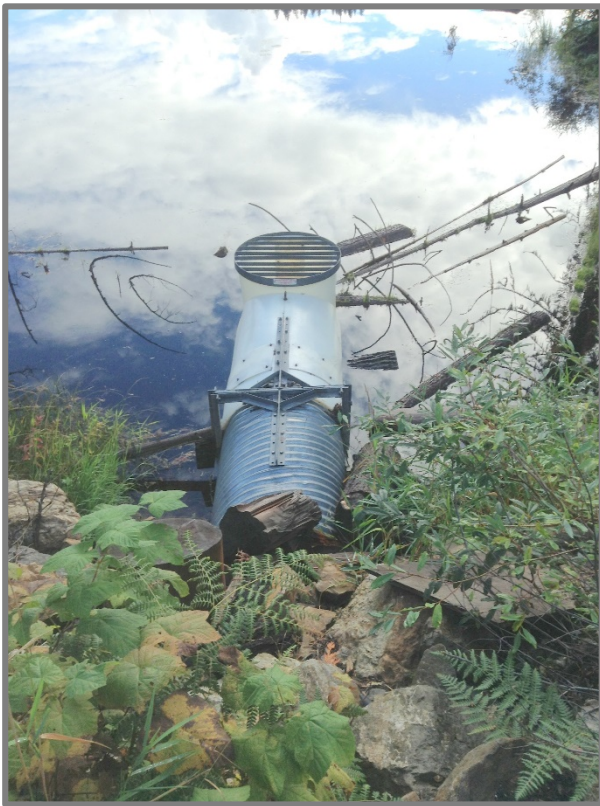
Figure 17. September 17, 2013 – The beaver proof culvert inlet.

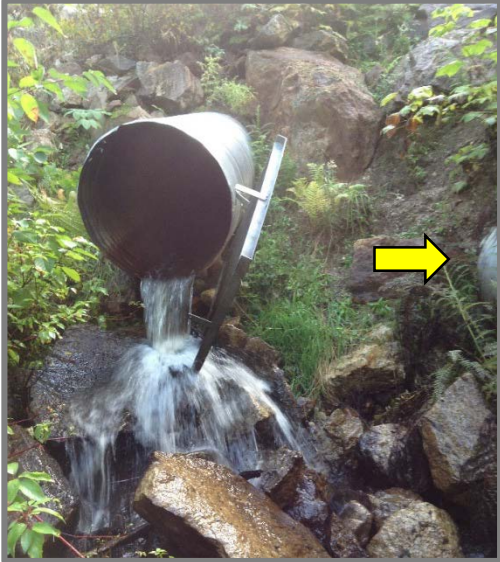
Figure 18. September 17, 2013 – The beaver proof culvert outlet. The original, lower culvert is just visible to the right, indicated by the arrow.

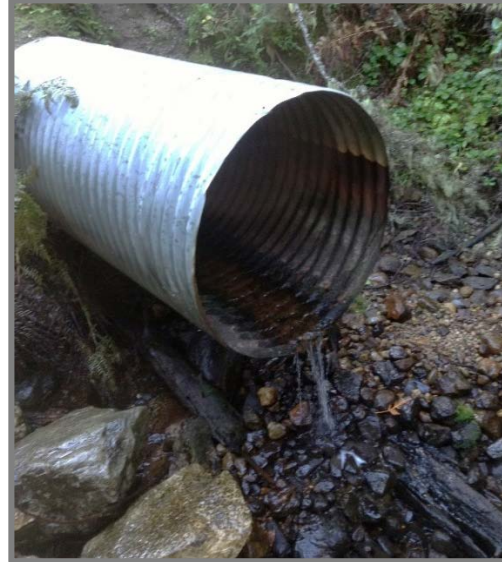
Figure 19. September 17, 2013 – The original culvert outlet is passing only a small amount of water indicating that it is almost completely blocked. Rust marks show how high the flow was in the past.

Tolko photos confirm that. As the lower culvert was almost completely blocked, BCTS did not ensure that drainage was maintained to the extent necessary to prevent adverse effects to forest resources.

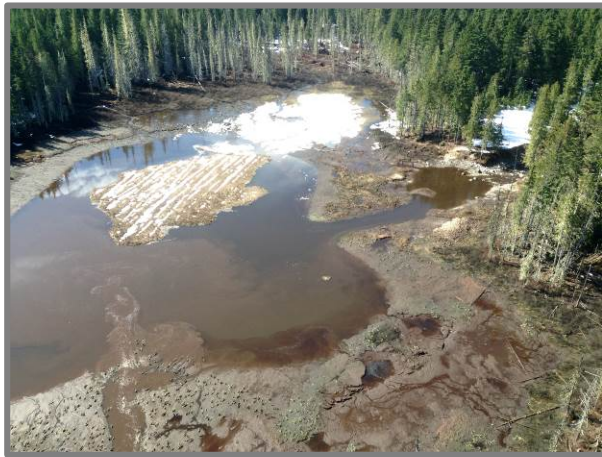
In the early morning of May 2, 2014, water from Dale Lake overtopped the Cooke Creek FSR, washed out the two culverts and sent a debris flood down Cooke Creek. The debris flood washed out the Cooke Creek FSR in two locations and overtopped the Enderby-Mabel Lake Road. It destroyed timber, utilities, and inundated the Kingfisher Salmon Hatchery and Interpretive Centre with debris, killing 60 000 salmon (See Map 2 and Figures 20-23).

Figure 20. May 2, 2014 – Dale Lake, less than five hours after the debris flood. The recreation site is the snow covered area in the top right corner.

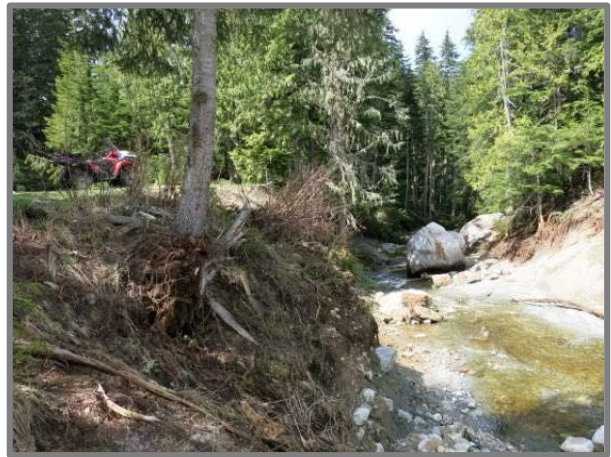
Figure 21. May 14, 2014 – Outlet of Dale Lake looking downstream. The ATV is parked on the Cooke Creek FSR beside the recreation site.

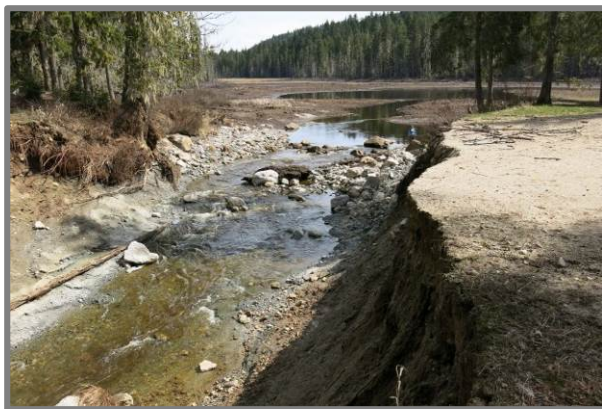
Figure 22. May 14, 2014 – Outlet of Dale Lake looking towards the lake. Picture taken from the Cooke Creek FSR.

The Cooke Creek debris flood was caused by the failure of two culverts at the outlet of Dale Lake. The inflow of water to Dale Lake exceeded the capacity of the culverts and the water level rose. A combination of head pressure, piping flows, fill saturation and overtopping and erosion of the road surface likely caused the outburst flood, releasing the stored flows catastrophically.

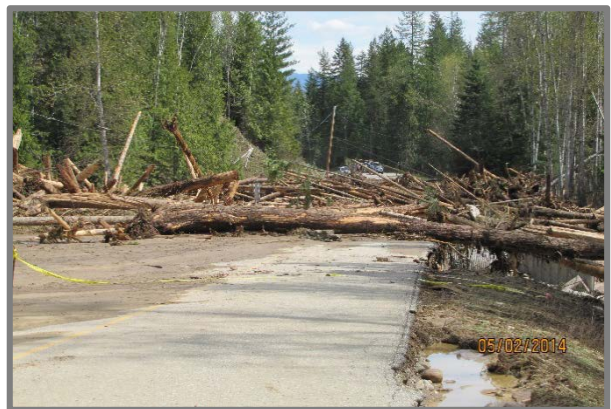
Figure 23. May 2, 2014 – The Enderby-Mabel Lake Road.
