Improvements in Bridge Design and Construction

In April, the Forest Practices Board published our second special investigation of bridge planning, design, and construction. The first bridge investigation found significant concerns with professional practice, environmental protection, and safety. This special investigation is a follow-up to the Forest Practices Board March 2014 report.

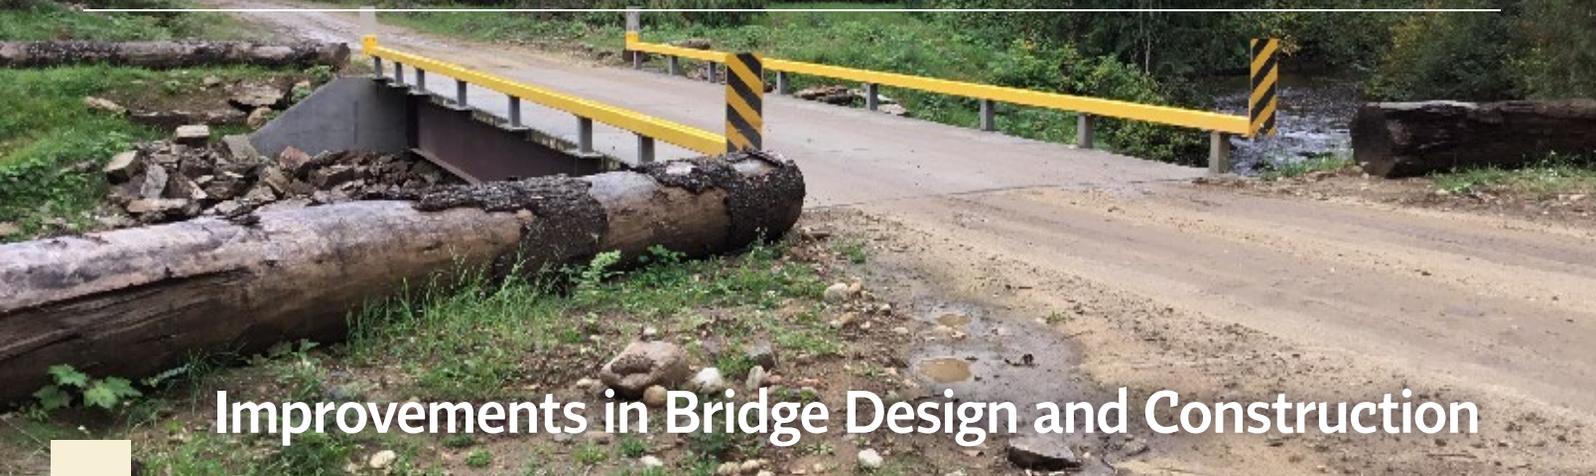
A simple crossing, spanning 18.29 metres (60 feet), over a class S3 stream on a forest service road in the Selkirk Natural Resource District.
